TECHNICAL ANNOUNCEMENT No. 12 - 2003

Model: Frame hydraulic tappets - California engine < see table

Subject: Noisiness of the timing system

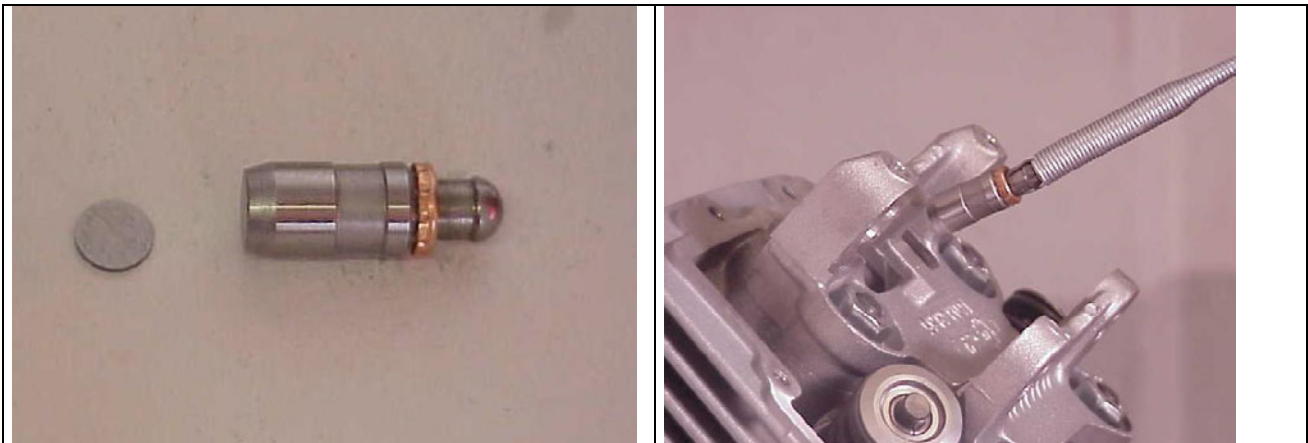
BY USING A LIGHT SOURCE, CHECK THAT THE CALIBRATED PAD IS FITTED INTO THE CLOSING.

FIT THE CALIBRATED PAD INTO THE CLOSINGS

IF A SIMPLE CHECK IS REQUIRED, THE CALIBRATED PAD CAN BE FITTED INTO THE CLOSING DIRECTLY FROM THE HEAD, WITHOUT DISASSEMBLING THE CAMSHAFT AND THE CLOSINGS.

IN THIS CASE, ATTACH THE CALIBRATED PAD TO THE TAPPET (BOTTOM PART), GREASING IT WITH ENGINE OIL IN ORDER TO STICK IT TO THE TAPPET AND TO EASILY INSERT THE TAPPET WITH THE CALIBRATED PAD INTO THE CLOSING.

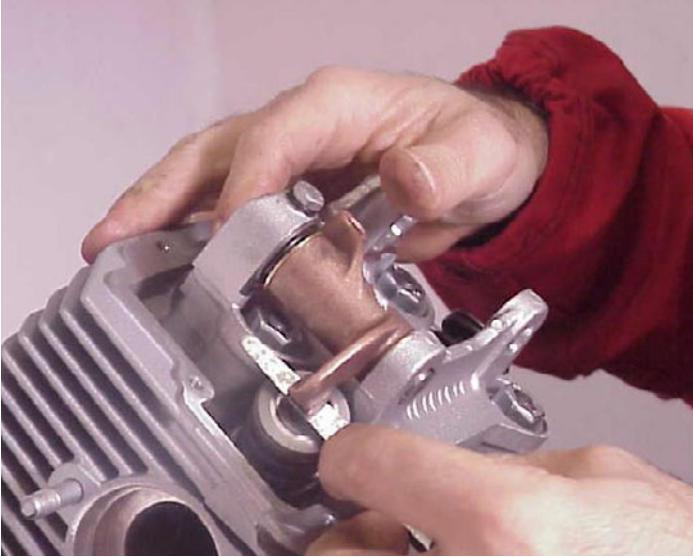
6

MEASURE THE CLEARANCE BETWEEN THE ROCKER ARM AND THE VALVE, BY HAVING CARE TO PUSH THE ROCKER ARM TOWARDS THE TIMING SYSTEM ROD (PERFORM THE SAME OPERATION ON BOTH VALVES)

IF > 1.1 mm THE CLEARANCE IS CORRECT, LEAVE THE CALIBRATED PAD IN POSITION
