EXHAUST SILENCERS

Model: Breva 750

TECHNICAL COMMUNICATION No. 02-2003

TECHNICAL ANNOUNCEMENT NO. 10 - 2003

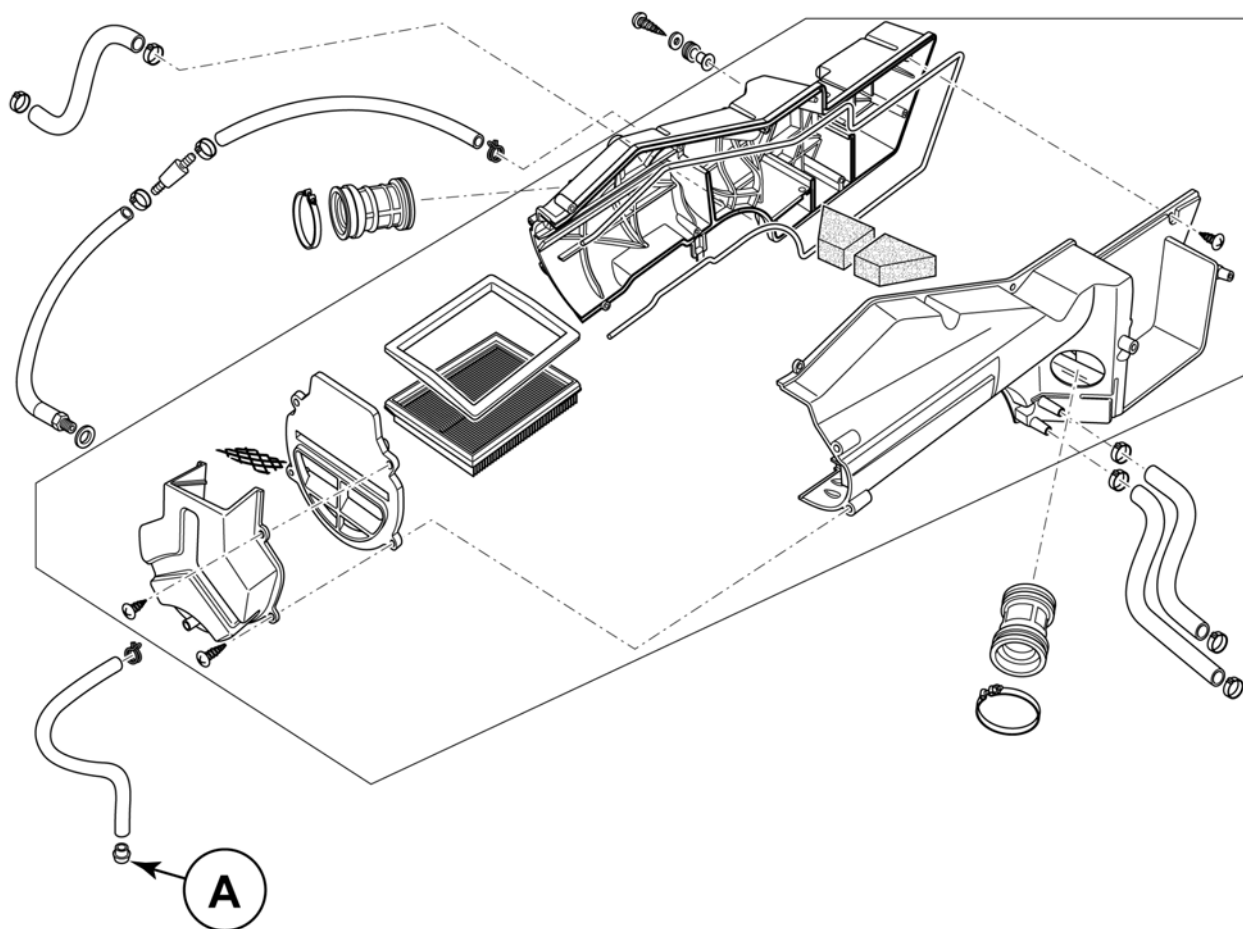
oil entering in the air box stays in the box bottom and goes out of the joints or the plug (A) fitted at the drain pipe end.

The problem was claimed on demo bikes or on bikes belonging to the first series produced only.

before fitting the air box to the vehicle, we check the air box sealing carrying out a leak test with air under pressure.

The plug (A) has been changed with a watertight plug.

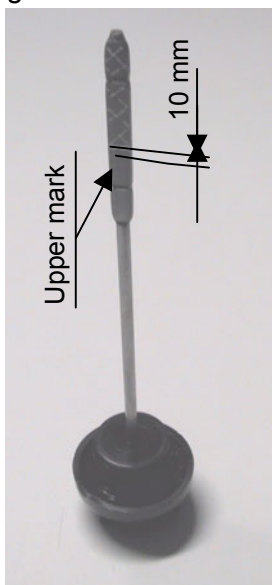
Fault experienced on vehicle: excessive quantity of oil extracted from the oil recover circuit.

Main cause: excessive quantity of engine oil.

An excessive quantity of engine oil can cause an increase in the oil extracted by the crankcase gas recover circuit. In exceptional cases an oil present in the transparent recovery tube, which extends from the filter housing to the rear joint of the right half cradle, type of anomaly can be experienced.

Technical solution: check and restore correct engine oil quantity (1.8 kg).

Check the correct engine oil level to avoid this inconvenience.

The checking operation can be easily carried out by using the oil filler cap dipstick. The correct quantity of oil wets the dipstick up to around 10-11 mm under the maximum level reference mark. The highlighted part in the photo shows the section of dipstick which must be wet. The check must be carried out with the engine warmed up, after around 20 minutes that it is running.

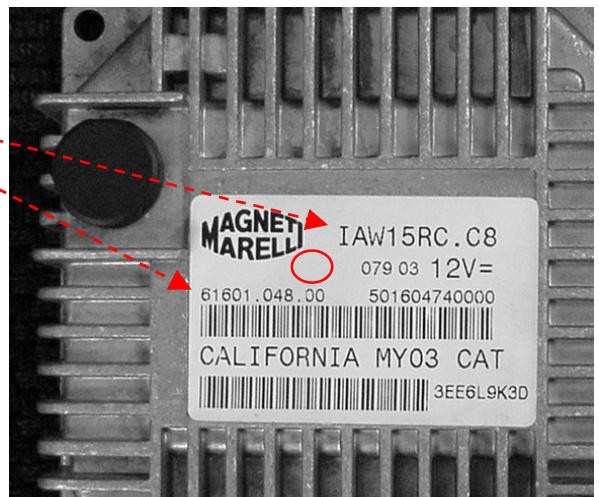
Defect found on vehicle: engine's irregular delivery

Possible cause: wrong gauging of the electronic control unit

Technical solution: control unit's replacement

Should the control unit assembled on the vehicle be incorrect, replacing it is indispensable.

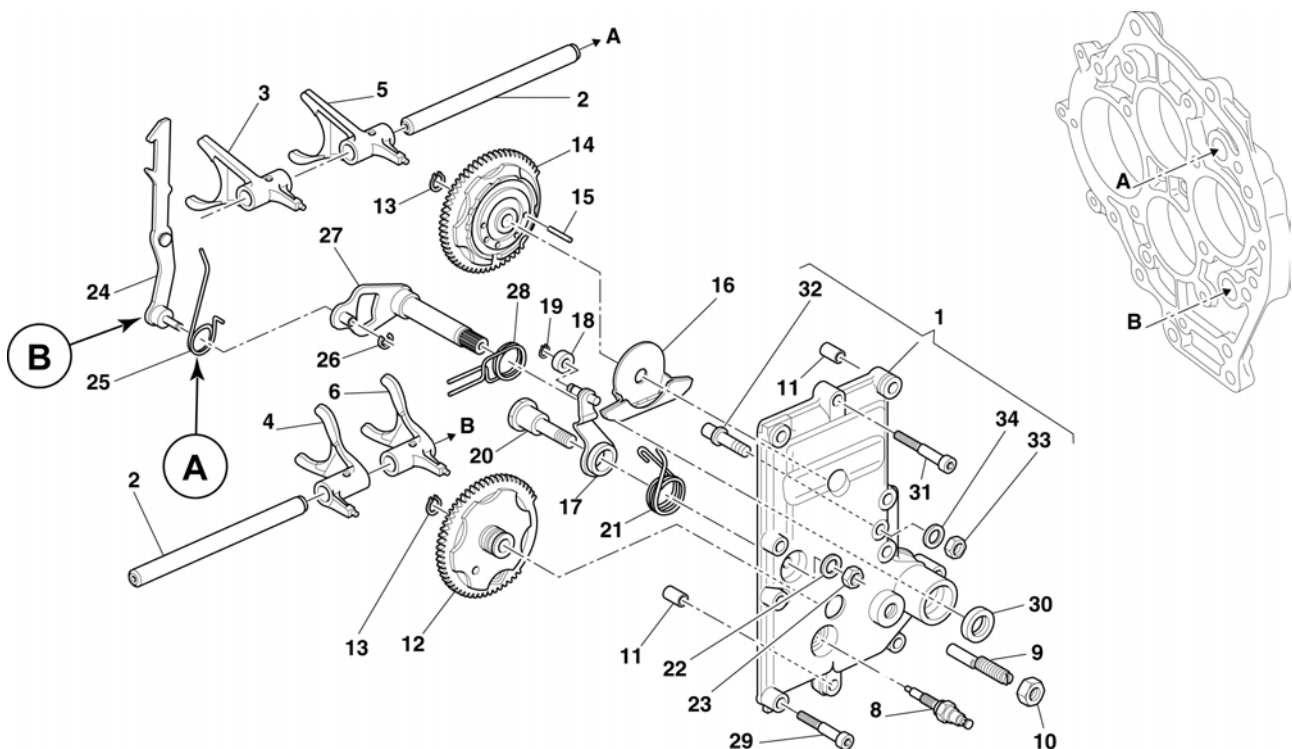
broken gear change pawl spring

In case of breakage of the pawl spring (**A**) in vehicles with frame numbers before **KT111435 - KS112350**, the pawl (**B**) should be changed (when asking for the spare part, you automatically receive the pawl updated version).

The change consists in the reduction of the diameter on which the spring rests from 16 mm to **15 mm**.
