EXHAUST SILENCERS

Model: Breva 750

TECHNICAL COMMUNICATION No. 02-2003

TECHNICAL ANNOUNCEMENT NO. 10 - 2003

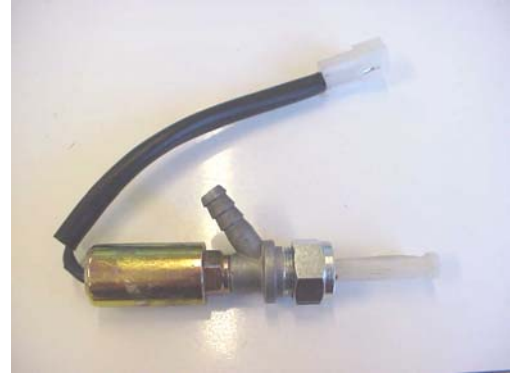
DIAGNOSTICS SHEET FOR THE NEVADA 750 ELECTRICALLY ACTUATED FUEL COCK

To unlock the cock, simply loosen the solenoid by one/two turns in relation to the body of the cock. It is recommended to remove the solenoid and replace the O-ring, which is available as spare part with 90706020 code.

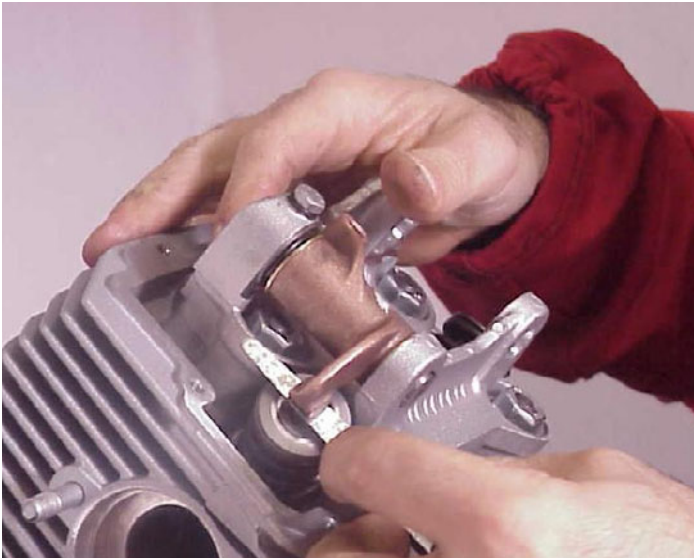
6

MEASURE THE CLEARANCE BETWEEN THE ROCKER ARM AND THE VALVE, BY HAVING CARE TO PUSH THE ROCKER ARM TOWARDS THE TIMING SYSTEM ROD (PERFORM THE SAME OPERATION ON BOTH VALVES)

IF > 1.1 mm THE CLEARANCE IS CORRECT, LEAVE THE CALIBRATED PAD IN POSITION

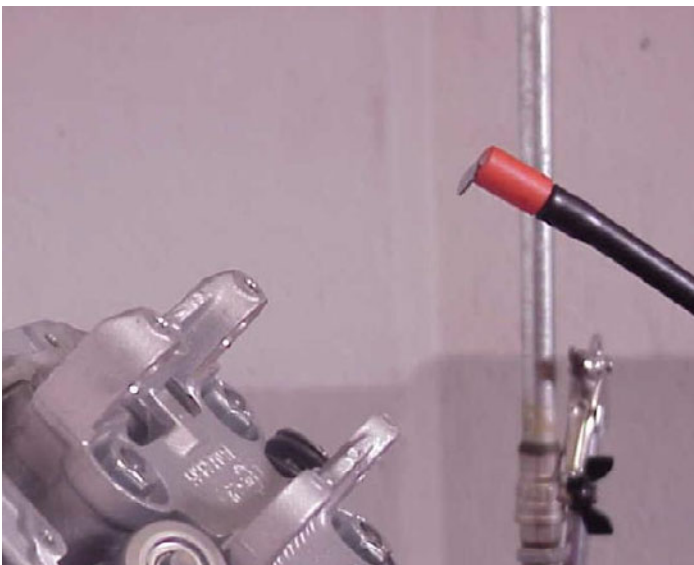
IF < 1.1 mm REMOVE THE CALIBRATED PAD (USE A MAGNET; SEE PHOTOGRAPH)

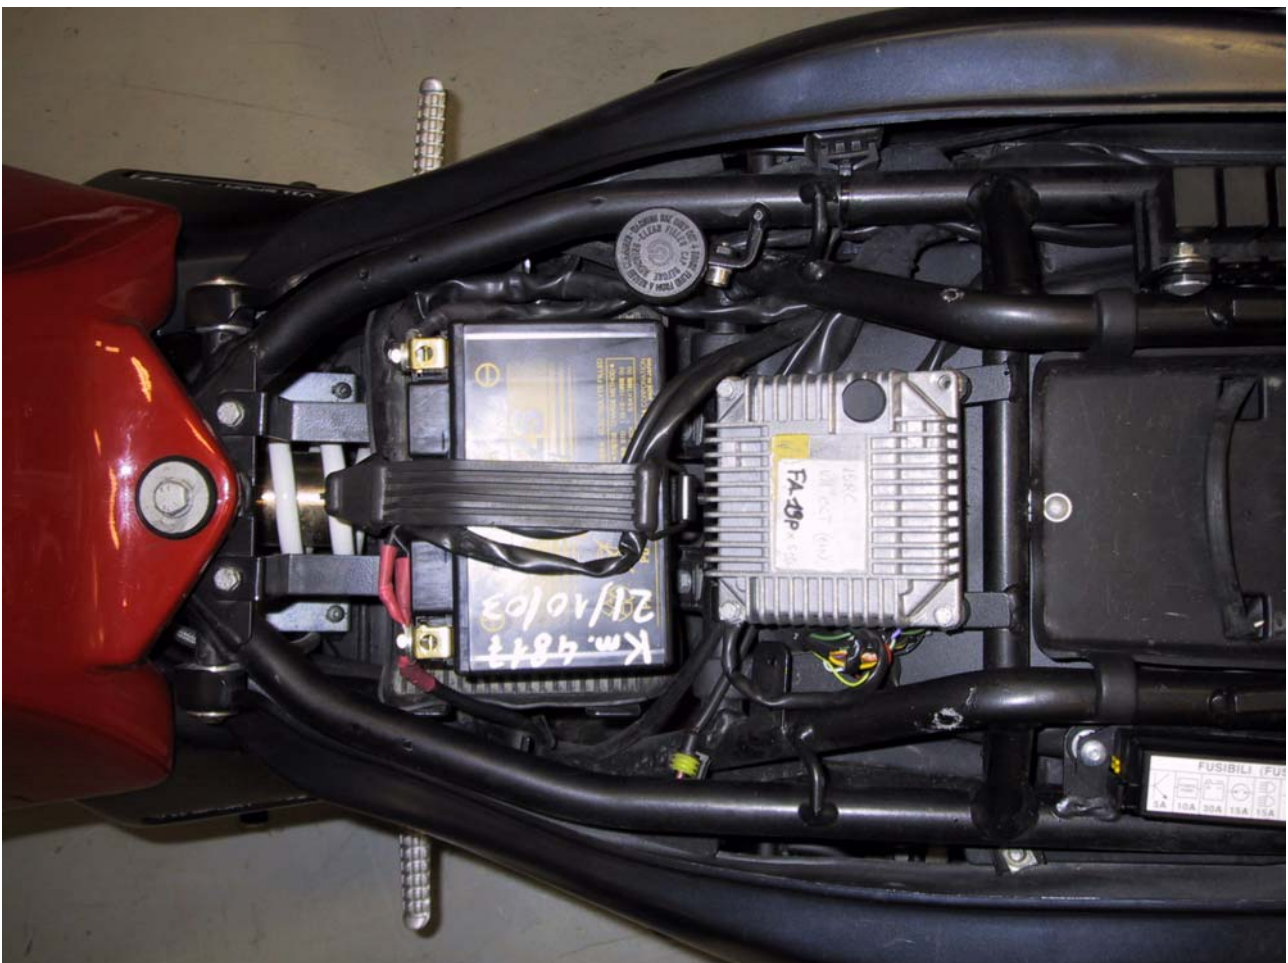
the **YUASA YTZ12S** battery will be fitted (comes from Yuasa already filled with fluid).

In production is fitted a new wiring while on bikes with present wiring it is possible to fit the battery and re-route the cables.
